**UNITED STATES DISTRICT COURT  
NORTHERN DISTRICT OF CALIFORNIA**

CHART INC.

) **COMPLAINT AND**  
) **DEMAND FOR JURY TRIAL**

## II. The Defect in Tank 4

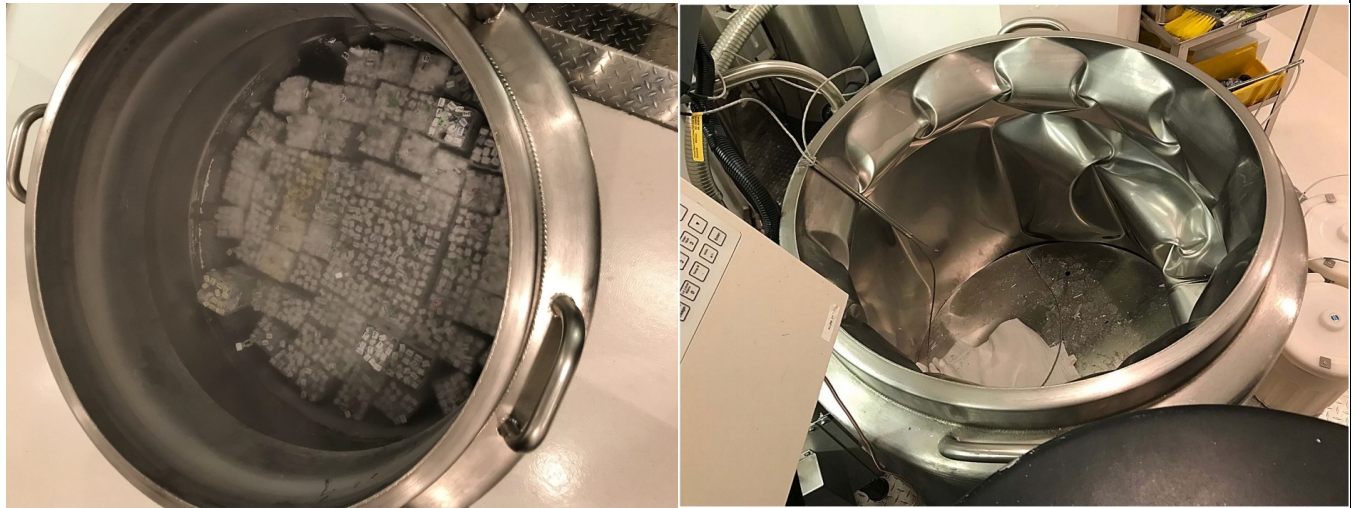
5. The cracked weld also triggered an implosion of the tank's inner vessel, as the liquid nitrogen that was sucked into the vacuum space transitioned to gaseous nitrogen and exerted pressure

on the inner vessel's walls. That is why the lid of the tank was difficult for PFC's embryologists to remove. The imploded tank is shown below, on the right:

*Normal Tank*

*Imploded Tank*

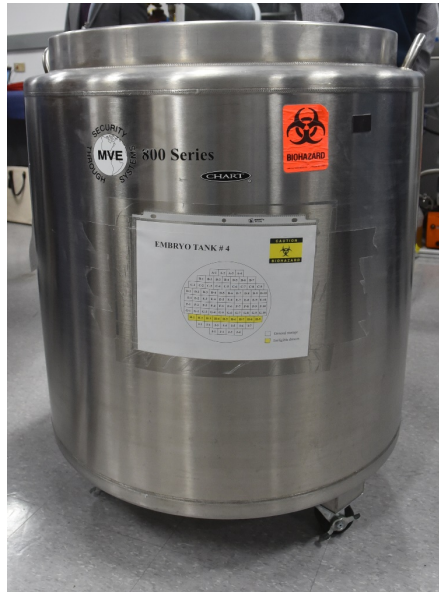
*Tank 4*

1           15.     The tank at issue in this litigation is an MVE-branded cryopreservation tank—  
2 specifically, a model MVE 808AF-GB Stainless Steel Freezer, which the embryologists at the Pacific  
3 Fertility Center referred to as Tank 4:

15           16.     The tank consists of the outer vessel seen above, an inner vessel that can be used to store  
16 eggs and embryos in liquid nitrogen, and an insulated vacuum layer that separates the two vessels and  
17 prevents heat transfer from the surrounding environment.

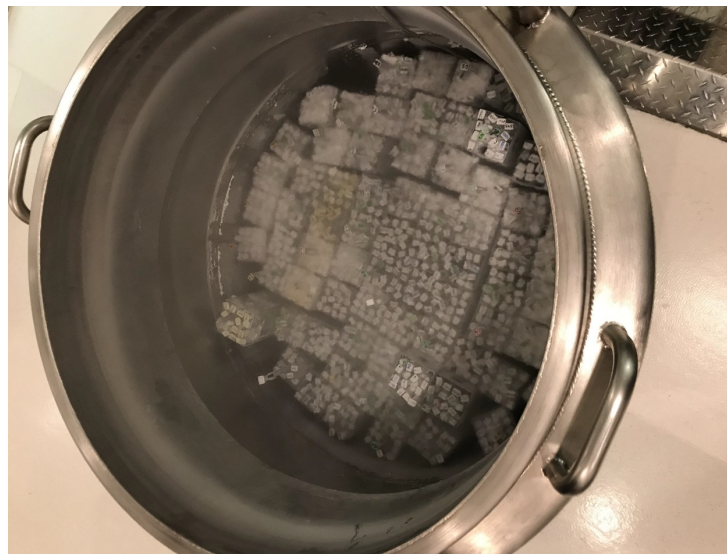
18           17.     The tank's inner vessel is shown below:

1           18.     The tank is filled with liquid nitrogen and dozens of boxes, each with further dividers  
2 that collectively can house hundreds of slender vitrification devices used to collect each respective egg  
3 or embryo.

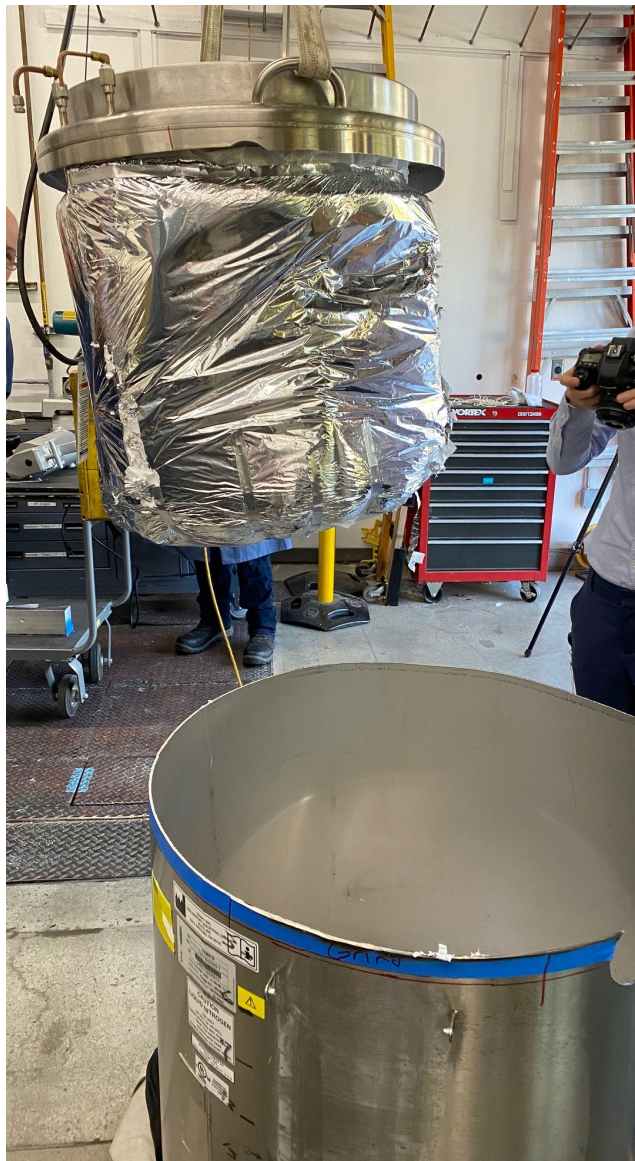
4           19.     The picture below was taken following failure of Tank 4 and shows the tank's inner  
5 vessel (wrapped in reflective material) being removed from the outer vessel. In between the two vessels  
6 was an interstitial space. Before a tank is put into service, Chart draws a vacuum within that space by  
7 sealing it shut and pumping out the air. The resulting vacuum space is what allows cryopreservation  
8 tanks to keep liquid nitrogen and biological samples at  $-198^{\circ}\text{C}$ .

*Tank 4's inner vessel suspended after removal  
from outer vessel (vacuum space was in between)*

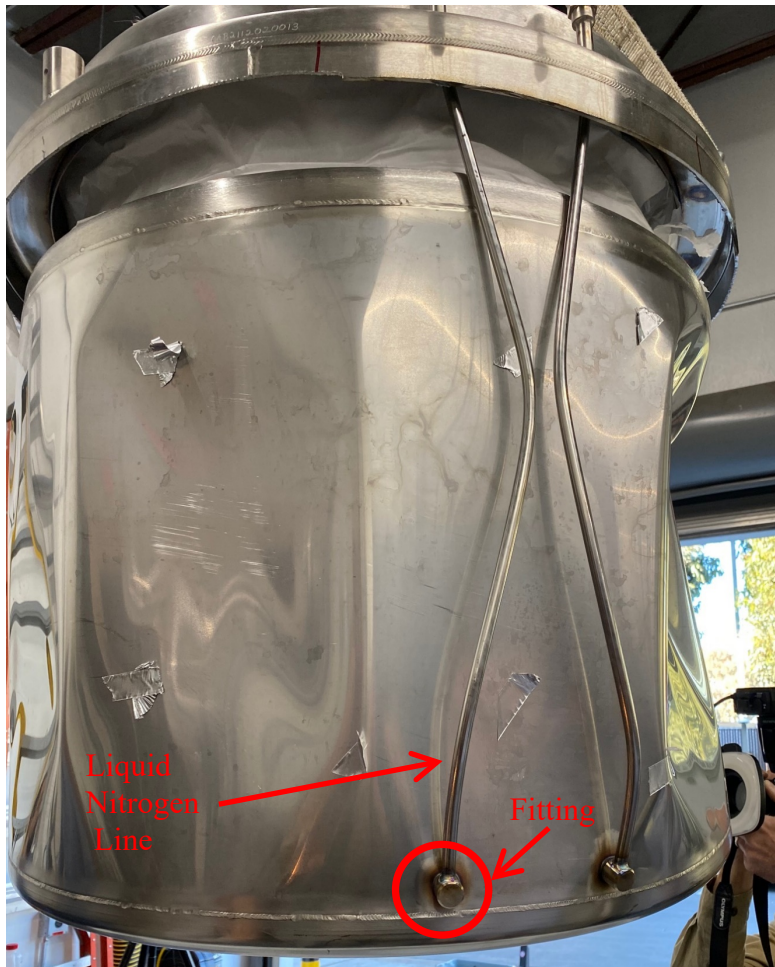
24. Tank 4 was manufactured with a metal tube that is used to refill the tank with liquid nitrogen. The tube ran from the top of the tank, down through the vacuum space between the inner and outer vessel, and then into the inner vessel near the bottom of the tank.

25. The picture below was taken after the outer vessel of Tank 4 was removed. The liquid nitrogen tube is on the left and the red circle shows where it connects to the inner vessel through a fitting.

*Liquid nitrogen tube feeds into Tank 4's inner vessel*

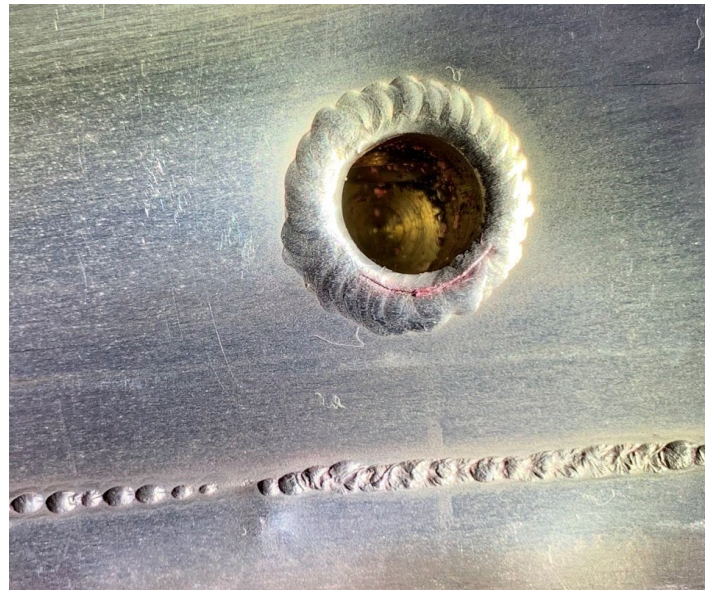
5           27.     The image on the right is the same weld, this time after using Magnaflux Spotcheck  
6 liquid dye penetrant. The fact the red dye penetrant remained after the surface was wiped clean is  
7 indicative of a crack.

*Red dye indicates a crack in the weld*

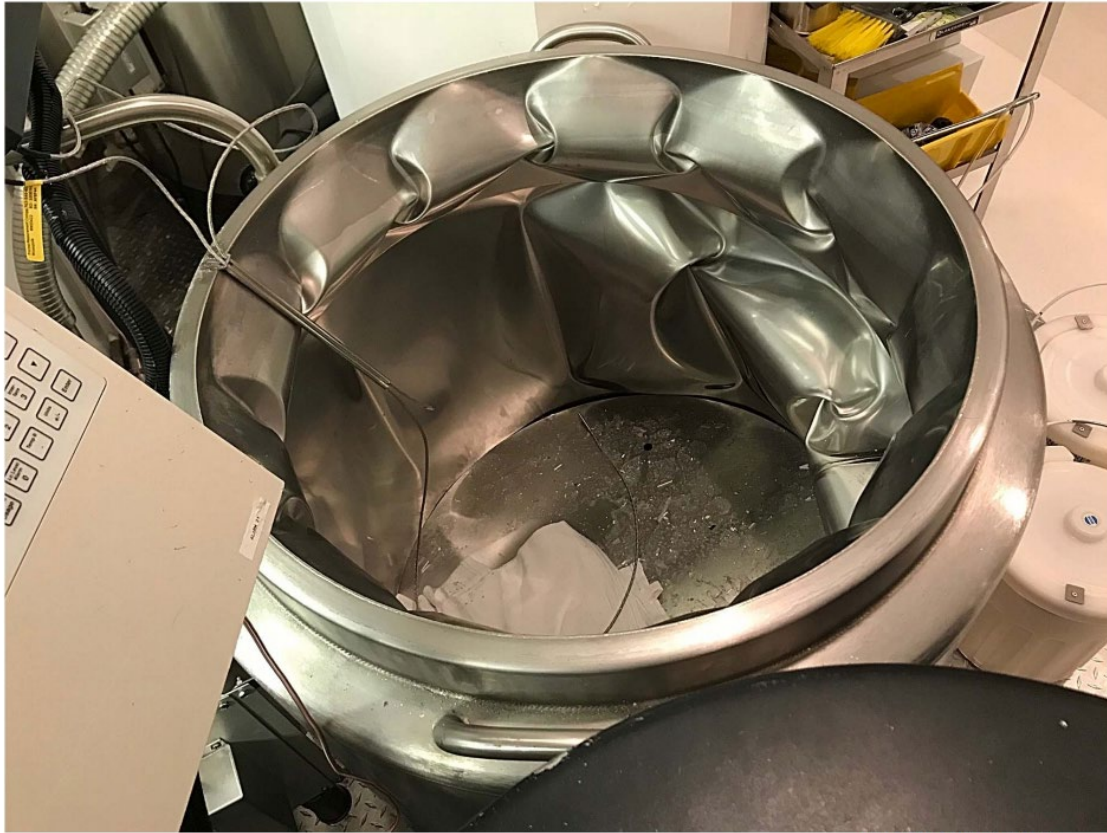
March 6, 2018, 9:03 AM

32. When the faulty weld cracked, the vacuum space was no longer separated from the inner vessel where PFC kept its patients' eggs and embryos. Liquid nitrogen was sucked into the vacuum space, where it expanded into nitrogen gas and pressurized the space between the inner vessel and outer vessel.

33. The crack and accompanying leak of liquid nitrogen into the interstitial space both destroyed the vacuum insulation that allowed the inner vessel to stay cold and exerted significant pressure on the space between the tank's inner and outer vessel. The inner vessel gave way and crumpled. The following image was taken approximately 36 hours after the PFC embryologists discovered the Tank 4 failure and moved the affected eggs and embryos to another tank.

*Tank 4 after the incident*
